CRITICAL SUBSTATION FAILURE

Rapid Response Done Right:

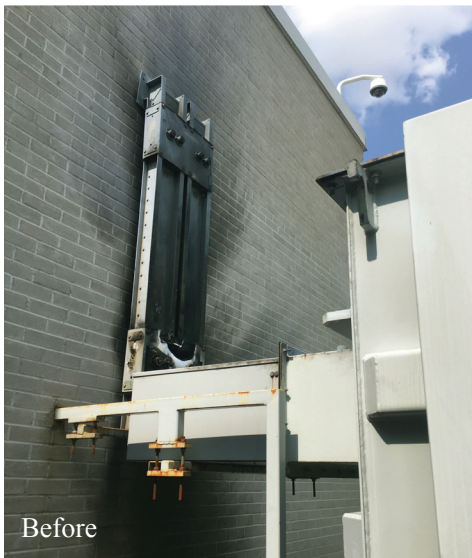
On the morning of Aug 14th, we responded to a large GTA Pharmaceutical customer who had completely lost power to their facility due to a catastrophic failure of the bus-duct that connects the main transformer and the 3000A main switchboard. For this company that develops and manufactures affordable prescription medications at their production facility in the GTA, a prolonged power failure would mean extremely steep production and business losses.

Upon receiving the call, the service team sprung into action to evaluate the situation, make it safe, and start preparing the switchboard for back-up power by disconnecting the damaged incoming bus-duct. Meanwhile, work began to source and deliver a large 1750KW, 600/347 emergency

The test results confirmed the worst fear that the transformer had suffered from a critical secondary bus-duct short, and an immediate replacement was required. Thankfully, with help from our partners, we were able to source a new in-stock 44KV replacement transformer.
